Complex analyses of surface, modelling and comparison of the 3D orthophoto to the real scale with historical cartography: mosaic surface of basilica of San Marco in Venice

Keywords: Analysis; digital photogrammetry; laser scanner; 3D modelling; orthoimage.

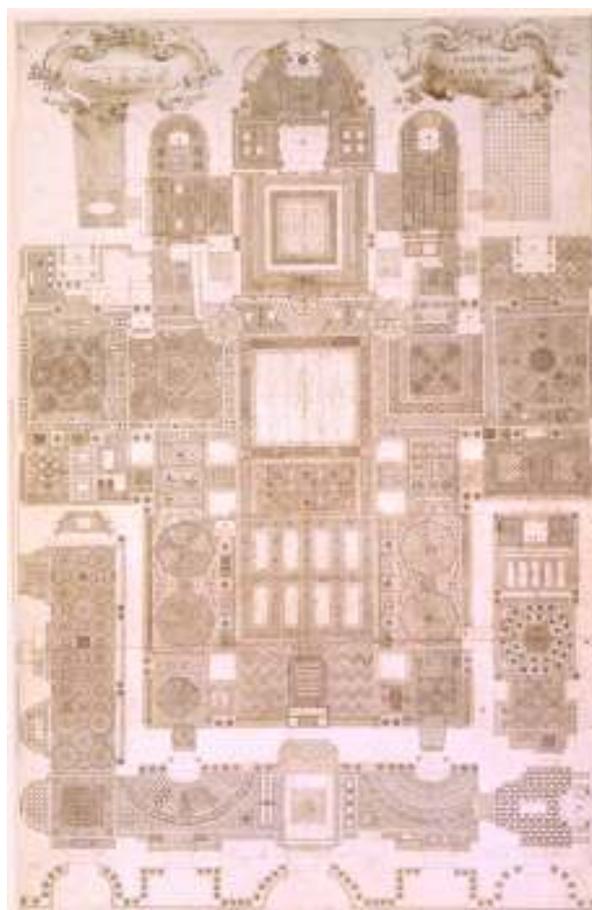
Figure 1. Sanguine pen drawing of the old mosaic floor of St. Mark's, work of Antonio Visentini (1720-25).

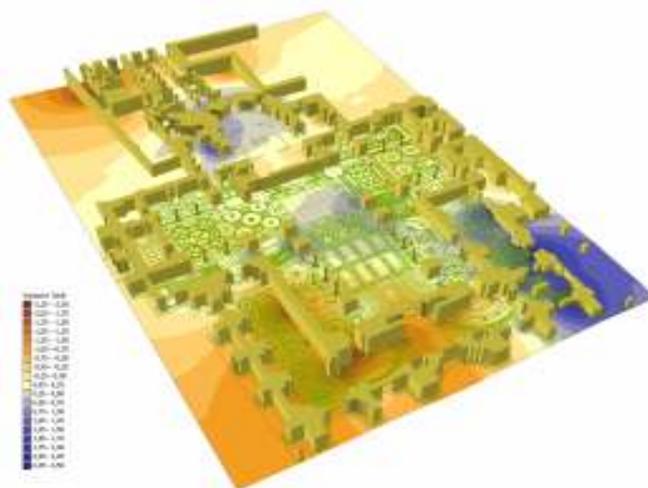
Figure 2. Control of the Basilica. Total variation of the structure in the period 1989-2005.

Since the late 1980s, the Procuratoria di San Marco (*Protectorate Board of St. Mark's*) decided to monitor eighty different control points on the load-bearing structure, mainly on walls not faced with marble (crypt and façade intrados) and above the marble wall facings, using high precision levelling. This was done to periodically monitor the structural movements, in view of the undulation of the top layer of floor mosaic. The movements are caused by past interventions, such as overloads relating to overlapping the wood and iron on the Byzantine domes done in the 13th century, as well load changes due to different settling of the sand screed of the subfloor and the foundations, the continuing effects of small terrestrial shocks, tide levels, flooding, and finally, subsidence that involved the entire northeastern Adriatic. Quarterly controls were conducted for several years to differentiate movements related to the effects of seasonal tide cycles from structural movements using a reference point located in the crypt. Monitoring is currently done annually. Over the years it was found that the Basilica moves largely due to seasonal changes, but the annual cycle is stable and the visible undulations of the floor cannot be correlated to movements in the Basilica (fig. 2, V.T. 89/04). After discounting abnormal movement due to certified causes (damage), the magnitude of the shifting varies from point to point and has not exceeded 1.5mm in 15 years. Over the last few years, the floor has been monitored and inspected in more than 1,000 points using precision level techniques. Its movements are quite sensitive to the upward thrust effects of tides (lagoon flooding). The undulations in the floor play an important role in the mosaic restoration processes.

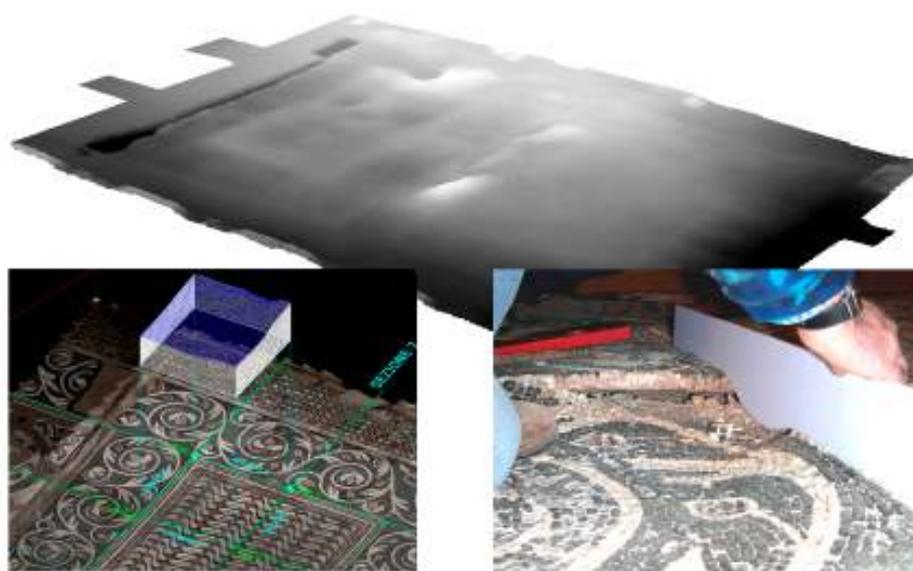
Figure 3. 3D model of the floor (DTM) to restore

The first area tested was the peacocks, using an orthophoto printed onto a transparency at a 1:1 scale to see the level of geometric matching and develop the chromatic matching, whose results were very satisfactory. The next step was survey of the area located in the right arm of the transept opposite the entrance to the Camera del Tesoro, inaccessible to visitors due to the restoration works underway to repair the deterioration that compromised the mosaic surface (fig. 3).

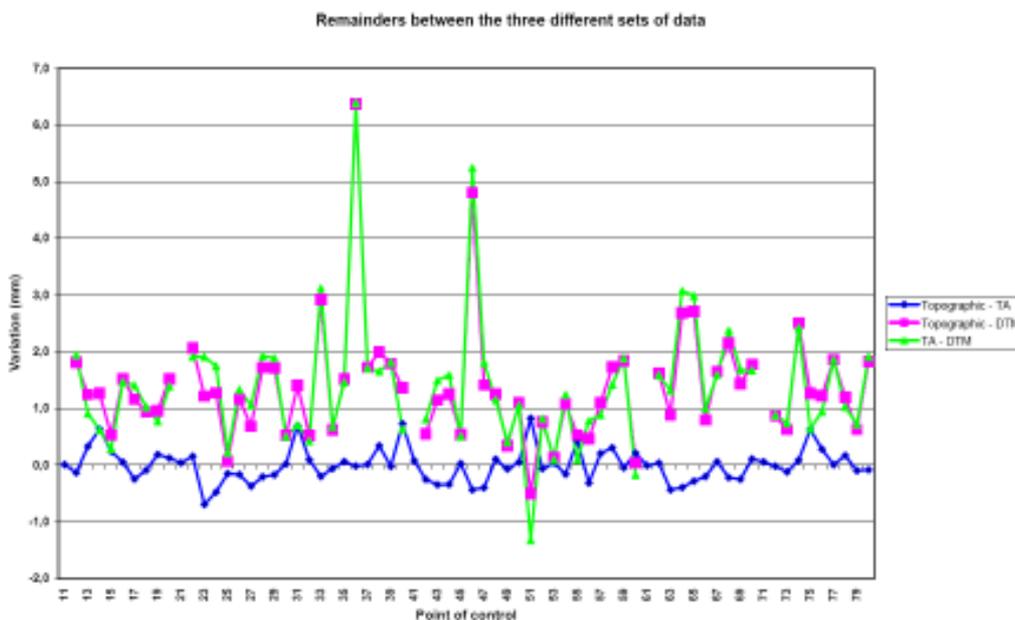
Figure 5. The remainders between the three different sets of data.

The last column provides the value of the planimetric distance between the vertices of support and the dead center position of the pixels of the DTM. Figure 5 represents the values of the remainders between the three different sets of data: the points for identification are located in abscissa; the values of the remainders in millimetres are given in ordinate. The specifications reached in a situation of extreme decay of the mosaic in the test area provide some comfort on the ability to extend the method to the entire floor.

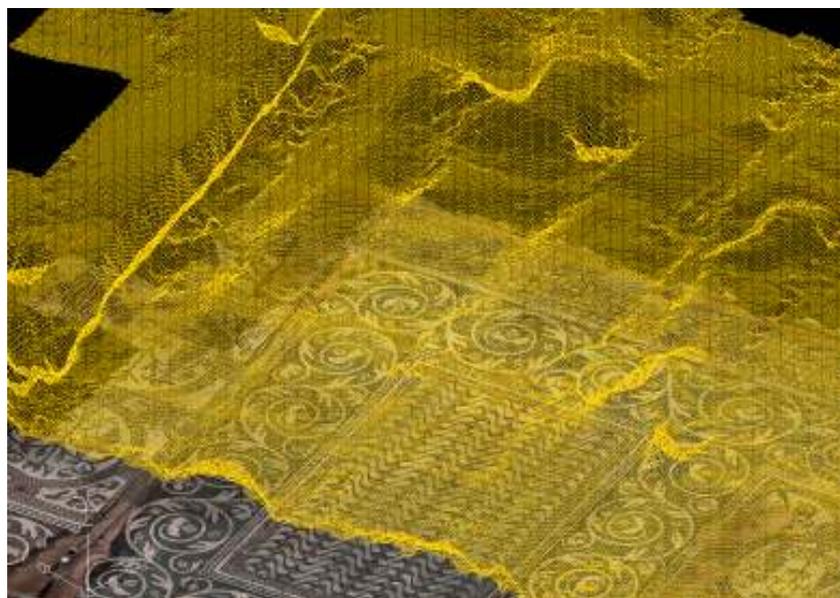
Figure 6. Test zone, the mosaic and the 3D mesh.

Where the mosaic is cracked (fig. 6), it is necessary to introduce break-lines in order to achieve a concrete adherence of the model made up of the orthophoto to the real model.

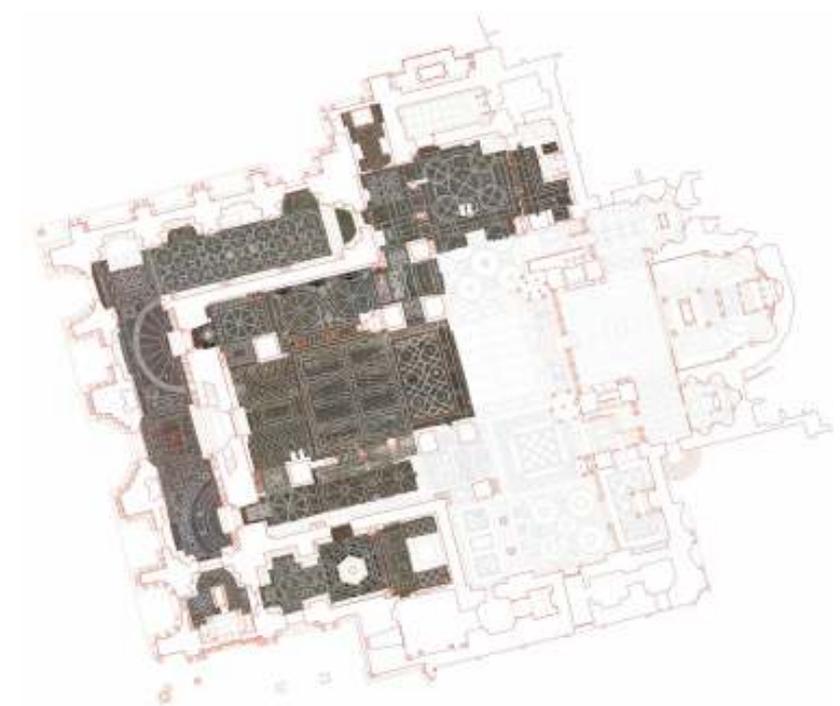
Figure 7. Orthophoto of the entire mosaic floor (May 2006).

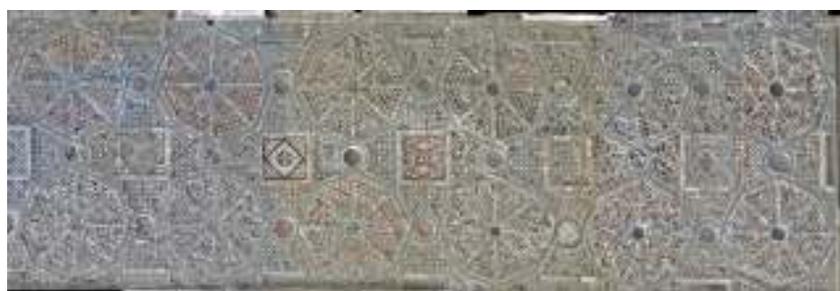
Figure 8. The orthophoto of narthex.

Rectification of the narthex began in the north area, 103 photograms on 190 support points, since it was more subject to movement of the mosaic in recent years.

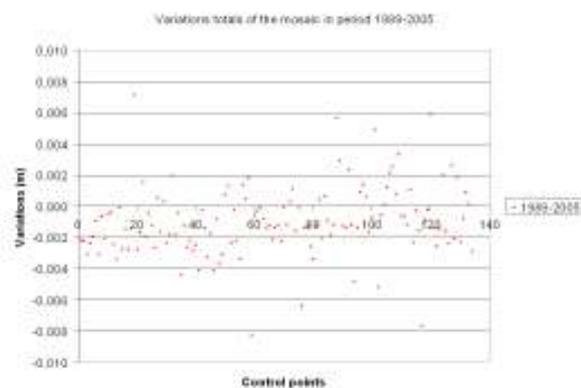
Figure 9. Total variation of the narthex floor in the period 1989-2005.

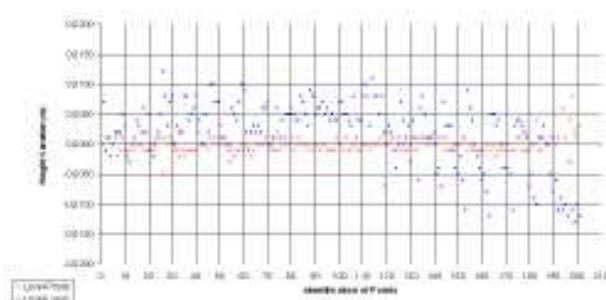
Figure 10. Photogrammetric control points. In ordinate are given the values of the remainders between of level height and DTM generated by photogrammetry and laser system.

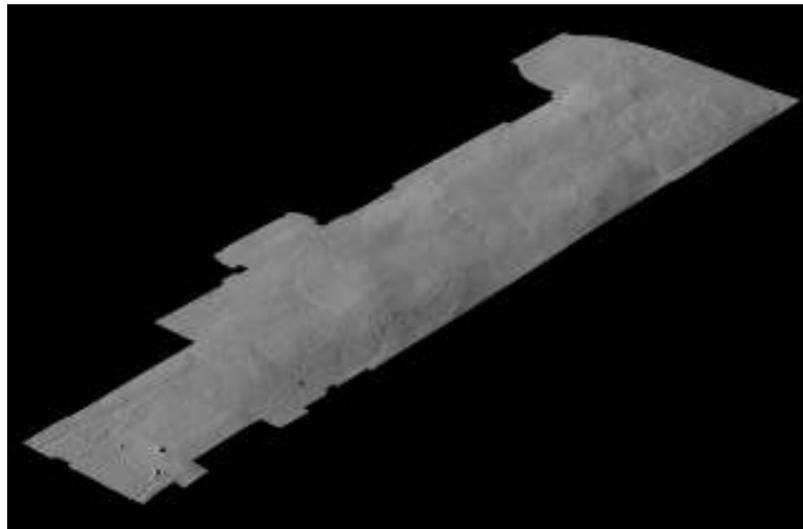
Figure 11. DTM generated by Leica HDS 3000.

A Leica HDS 3000 laser scanner was used in the narthex to compare with DTM from automatic image matching and to have the risers. The intention is to obtain a realistic and precise representation of the entire floor inside the Basilica, represented by a model in elevation consistent with the floor and the sections at the 1:50 scale.

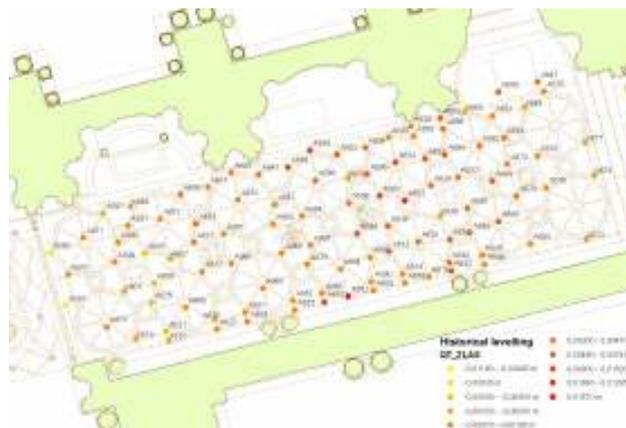
Figure 12. Comparison between the level height of the 2005 and extracted height from the data laser scanner (historical points).

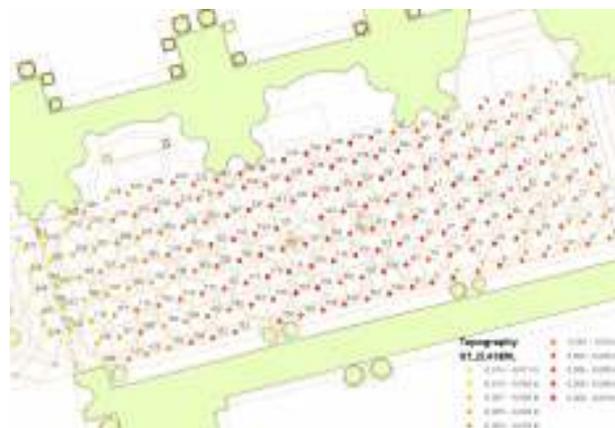
Figure 13. Comparison between the level height of the photogrammetric check points and the extracted height from the lattice (generated from the data laser scanner).

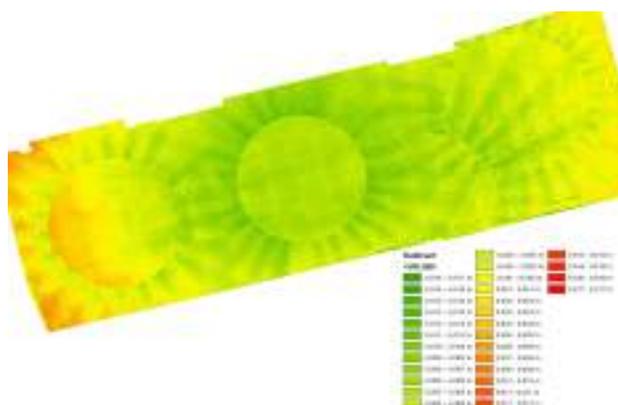
Figure 17. Raster calculator from ArcInfo: the image represents the difference between the DTM photogrammetric and laser.

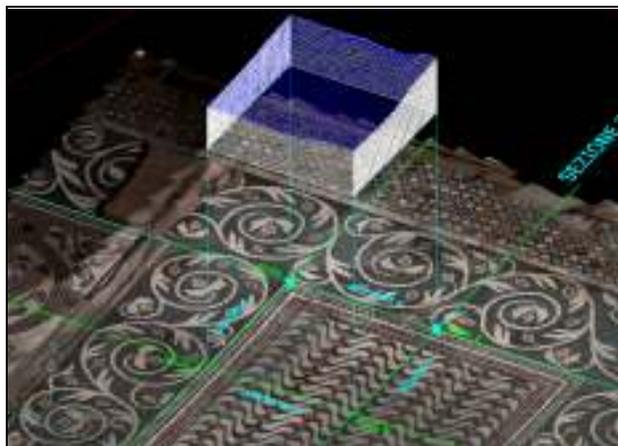
Figure 18. Test zone, reverse engineering of the mosaic. DTM generate by automatic image matching.

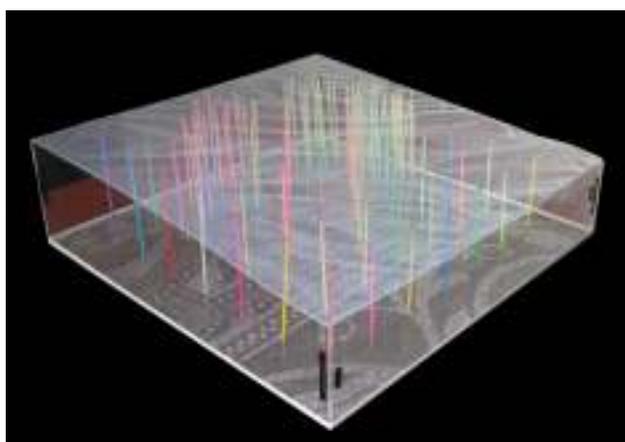
Figure 19. Test zone, 3D real model.

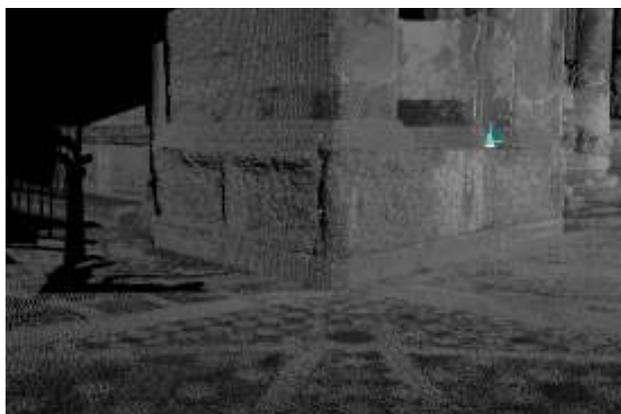
Figure 20. Registration of clouds laser scanner.

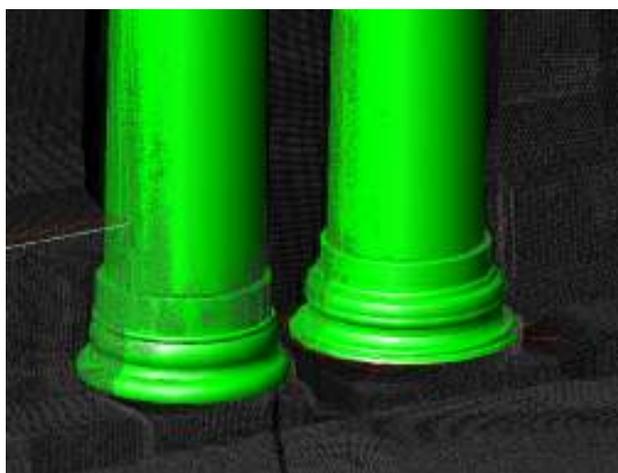
Figure 21. Construction of the model 3D, generated by the data laser, particular.

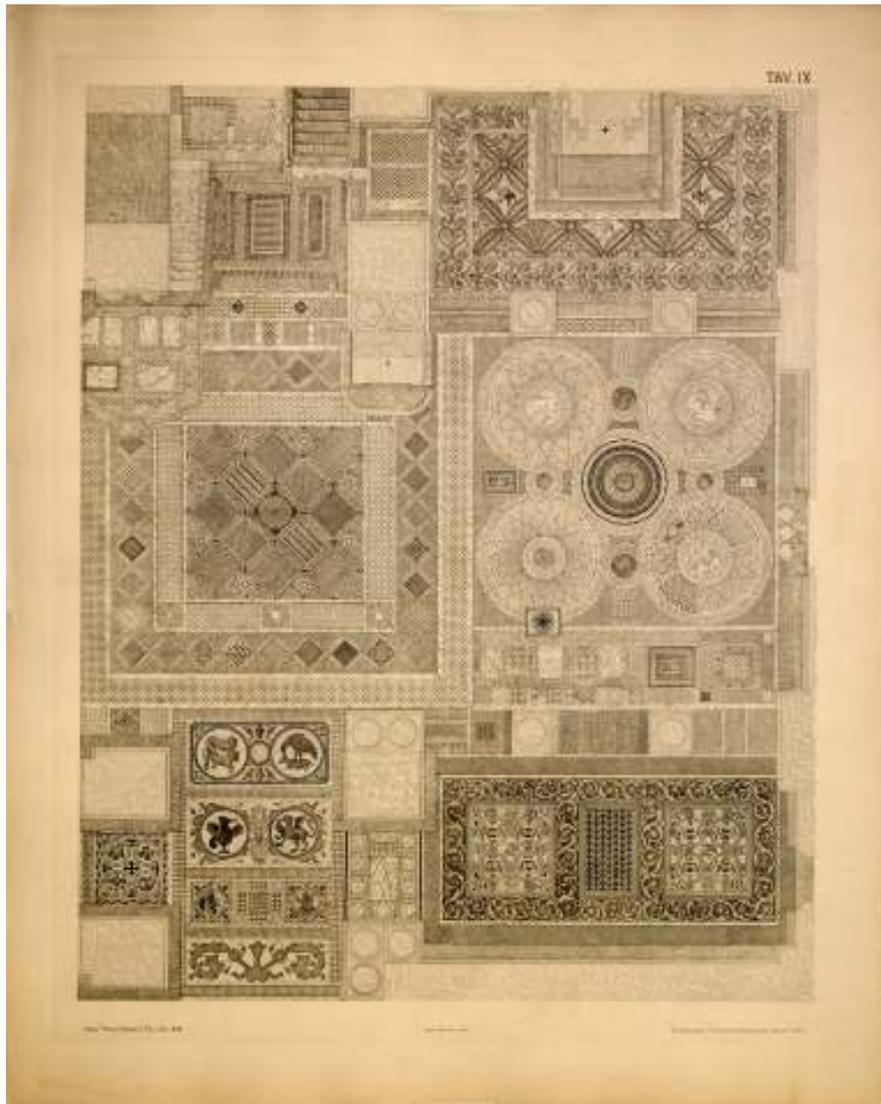
Figure 22. Drawing of the old mosaic floor of St. Mark's, work of Moretti 1882.

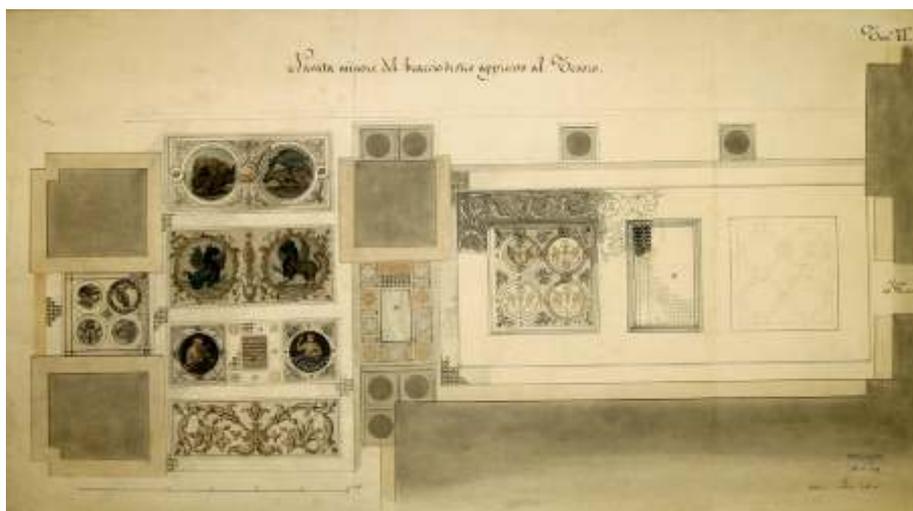
Figure 23. Drawing of the old mosaic floor of St. Mark's, work of Pellanda 1850-70.

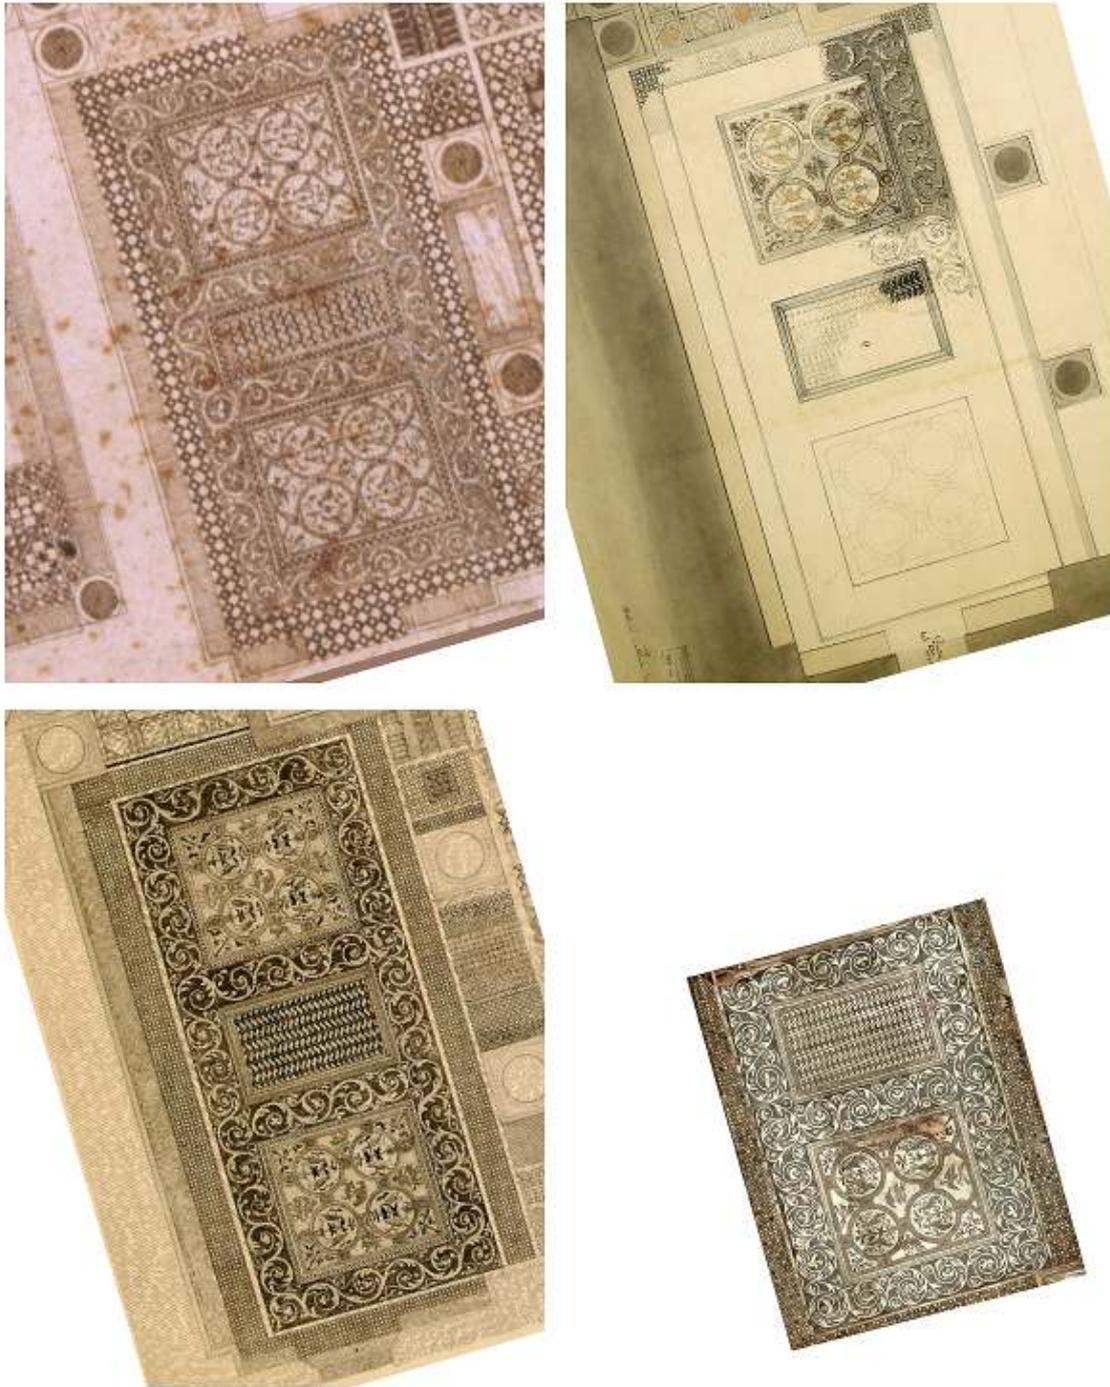
Figure 24. Comparison of the historical documents with the actual orthophoto.

The GIS software permit to register and to catalogue historical documents, to classify materials and chemical-physical analysis, and more, until the comparison with the historical map who represent the pavement's mosaic. The historical map, as regards as an only reference system, become directly comparable with the actual relief, allowing to extract useful informations for the conservation project. Comparing the relief dating 1720-25 of Visentini, with the relief of Moretti dating 1882, and Pellanda dating 1850-70, until the actual 3D orthophoto at real scale we can see as in the time in a particular of the mosaic representation in the Sud transept, some represented subjects resulting first rotated in one sense, than in an another (at the end we could see how they has been reported at the original position...the most antique).

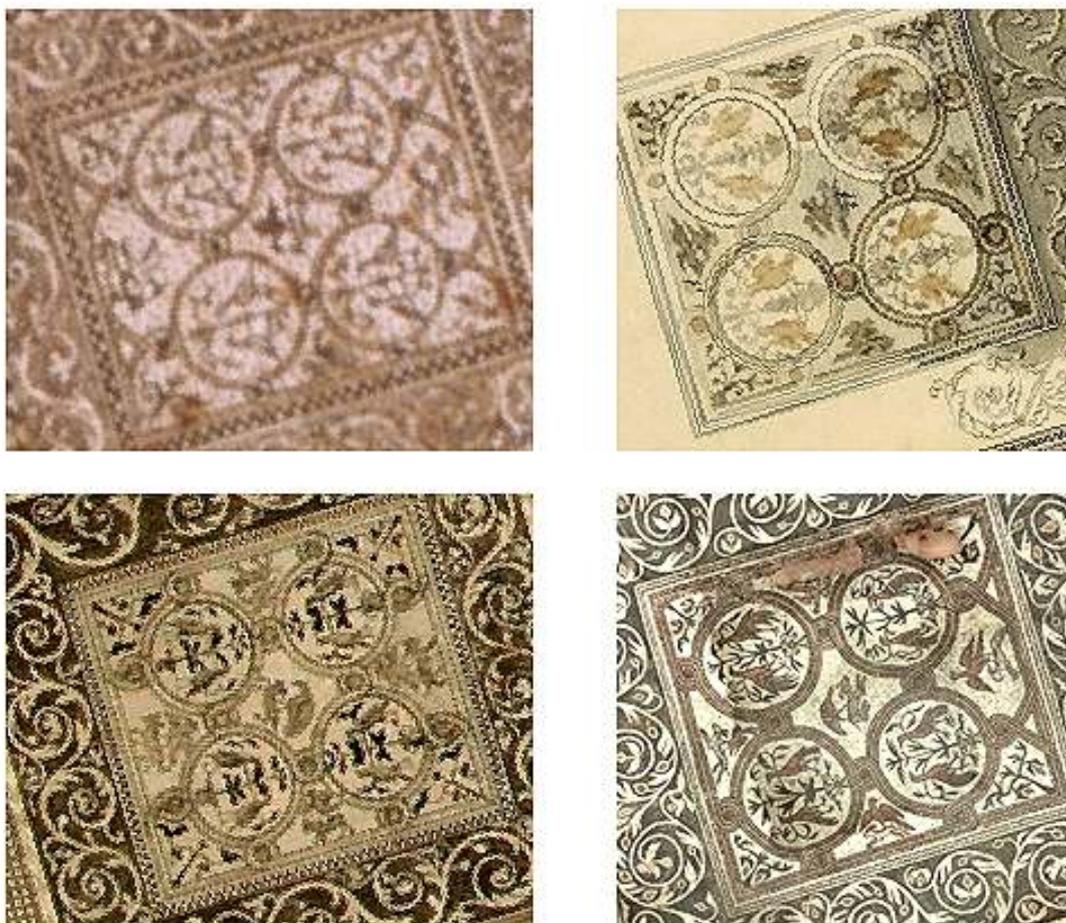
Figure 25. Comparison of the historical documents with the actual orthophoto (particular).
